Debris/Ice/TPS Assessment And Photographic Analysis For Shuttle Mission STS-35

Gregory N. Katnik
NASA/Kennedy Space Center

DEBRIS/ICE/TPS ASSESSMENT
AND
PHOTOGRAPHIC ANALYSIS
OF
SHUTTLE MISSION STS-35

December 2, 1990

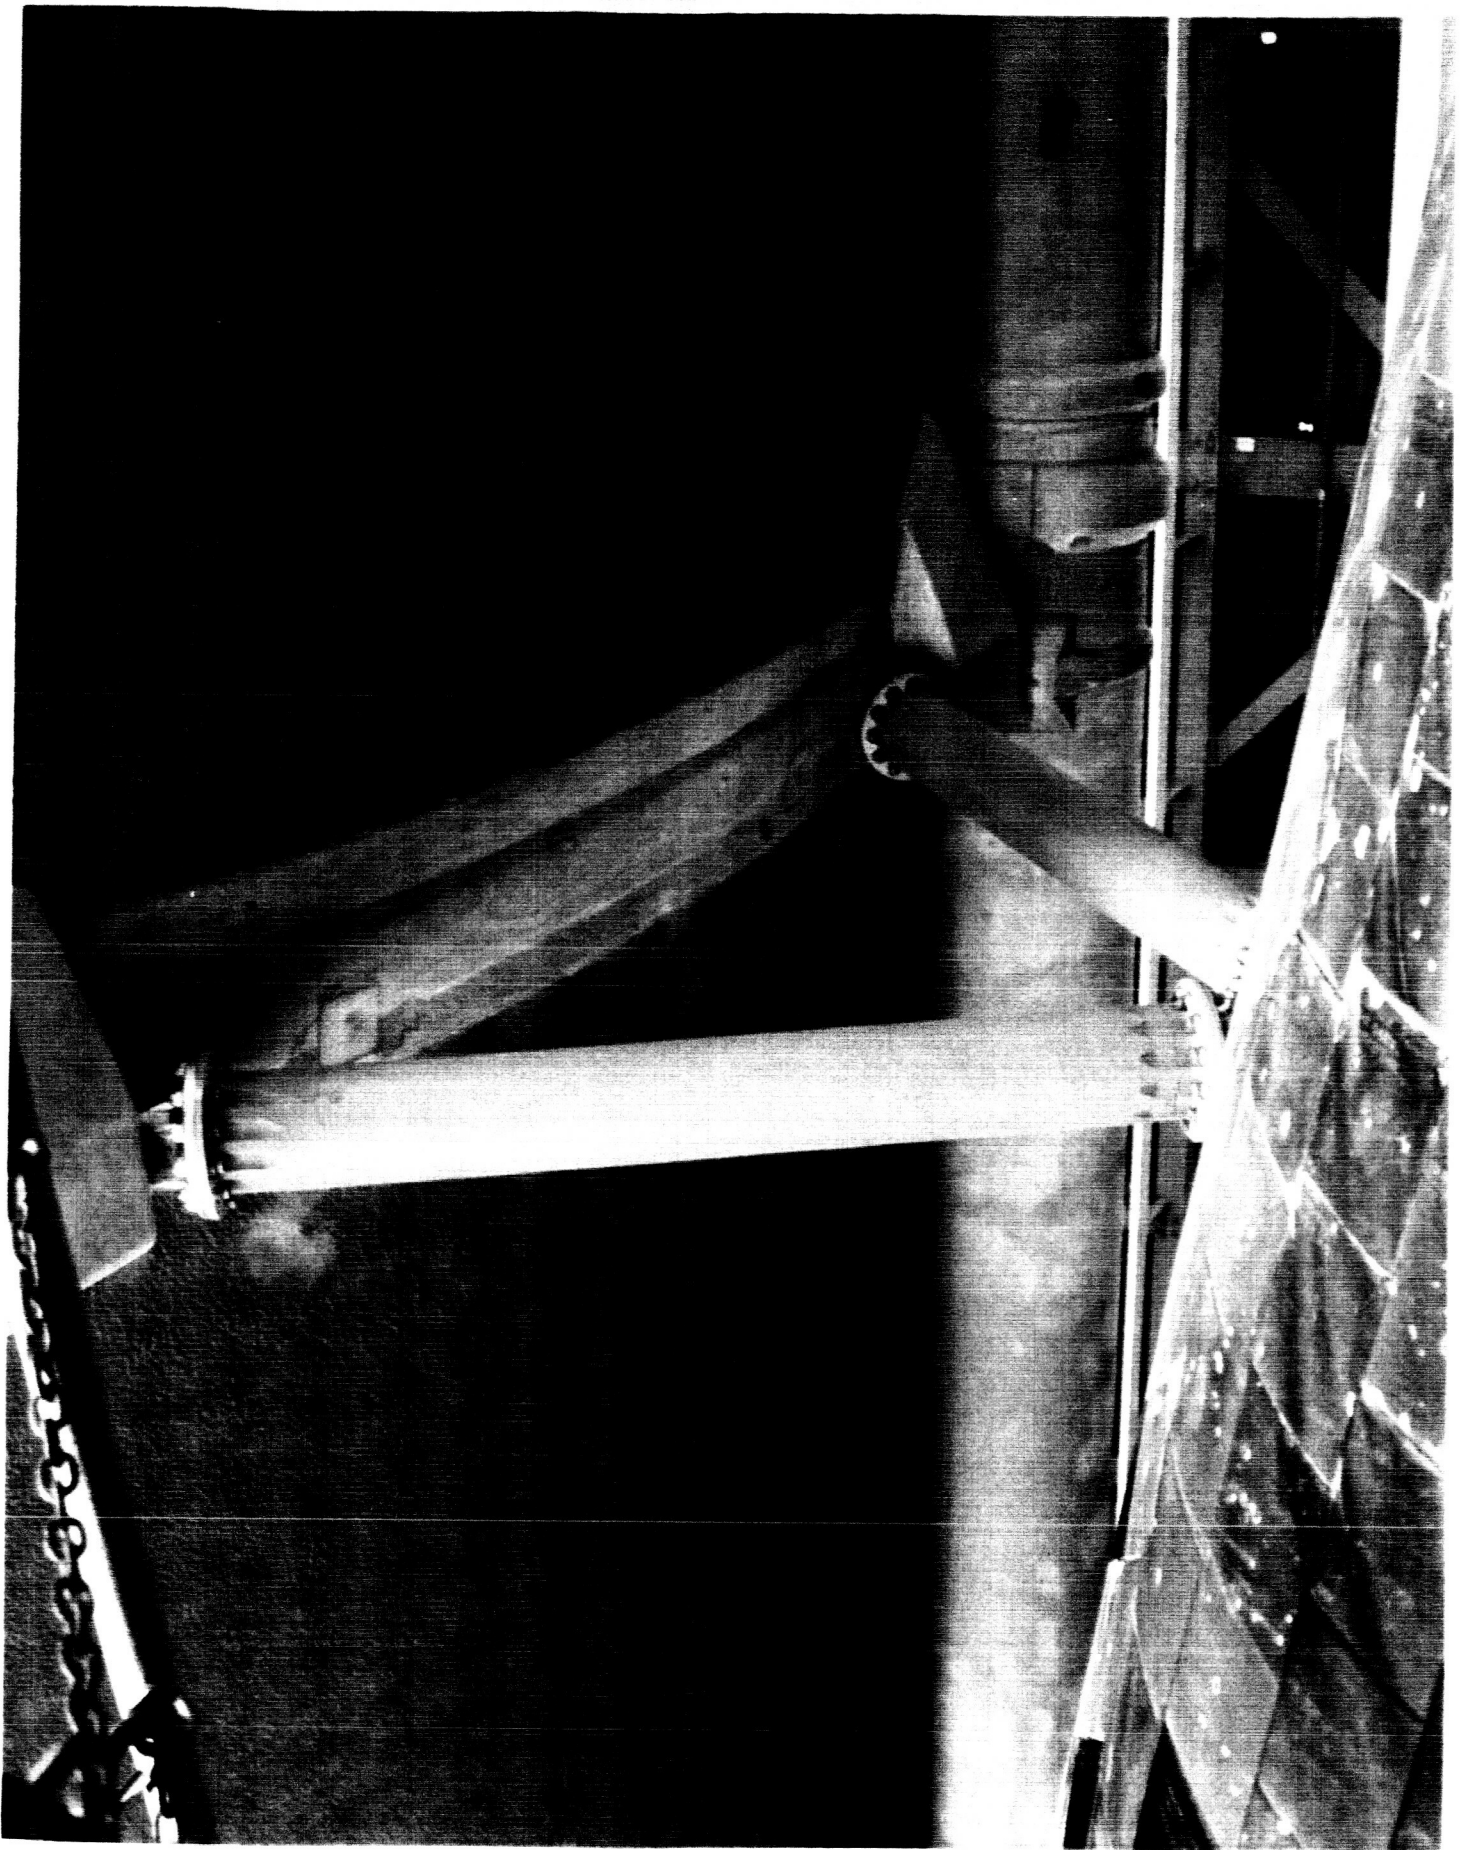
Pre-launch configuration of intertank/upper LH2 tank acreage
TPS. Black markings show location of drilled vent holes.

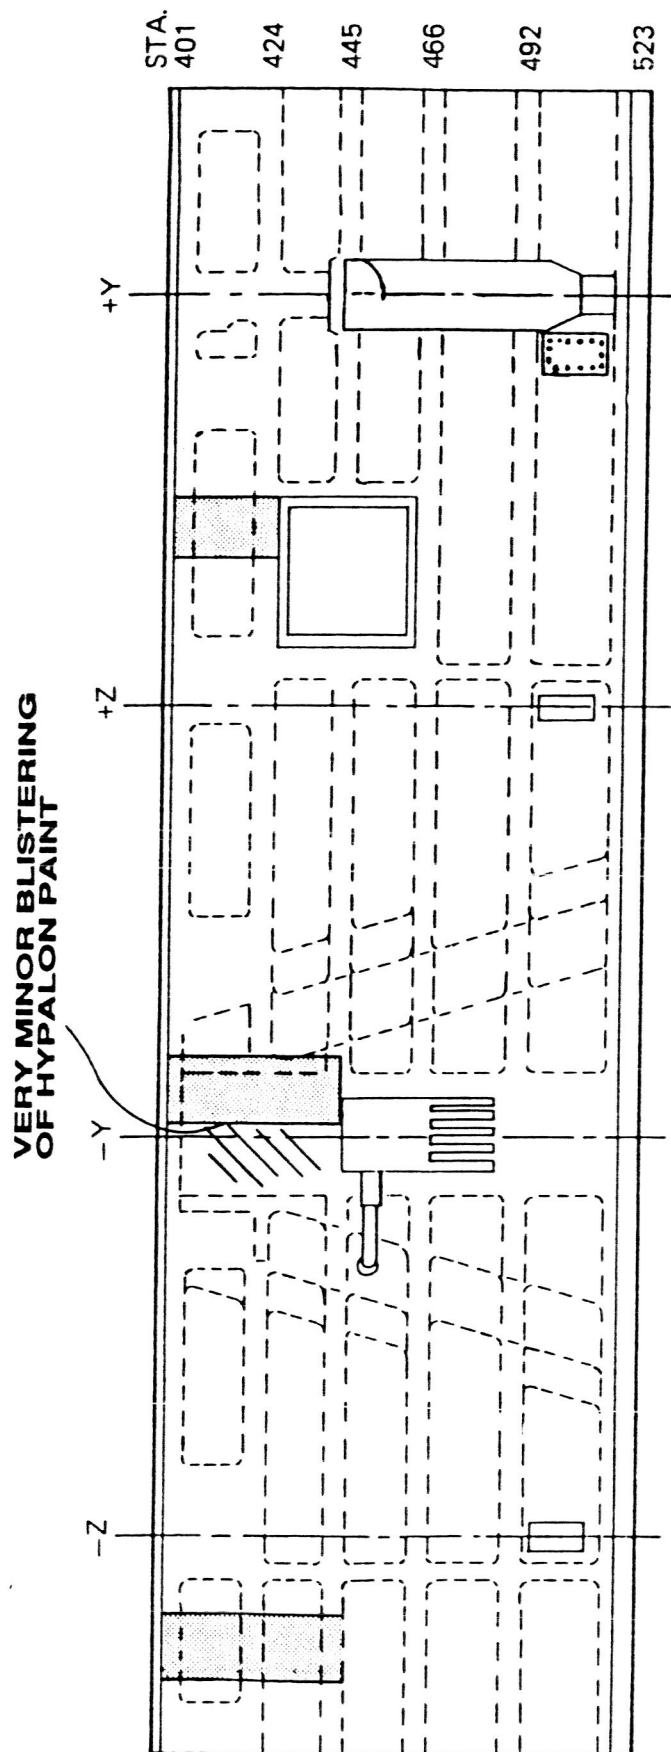
FIGURE 6. RIGHT SRB FWD SKIRT

The RH forward skirt exhibited no debonds or missing TPS (Figure 6). The phenolic plates on both RSS antennae were not delaminated. The forward separation bolt and electrical cables appeared to have separated cleanly. K5NA closeouts on the inboard corners of the RSS interface cable tray were intact. The frustum severance ring, utilizing new pin retainer clips and lockwire, was missing no pins.

<u>MISSING TPS</u>	<u>DEBONDS</u>
NONE	30 DEBONDS OVER FASTENERS

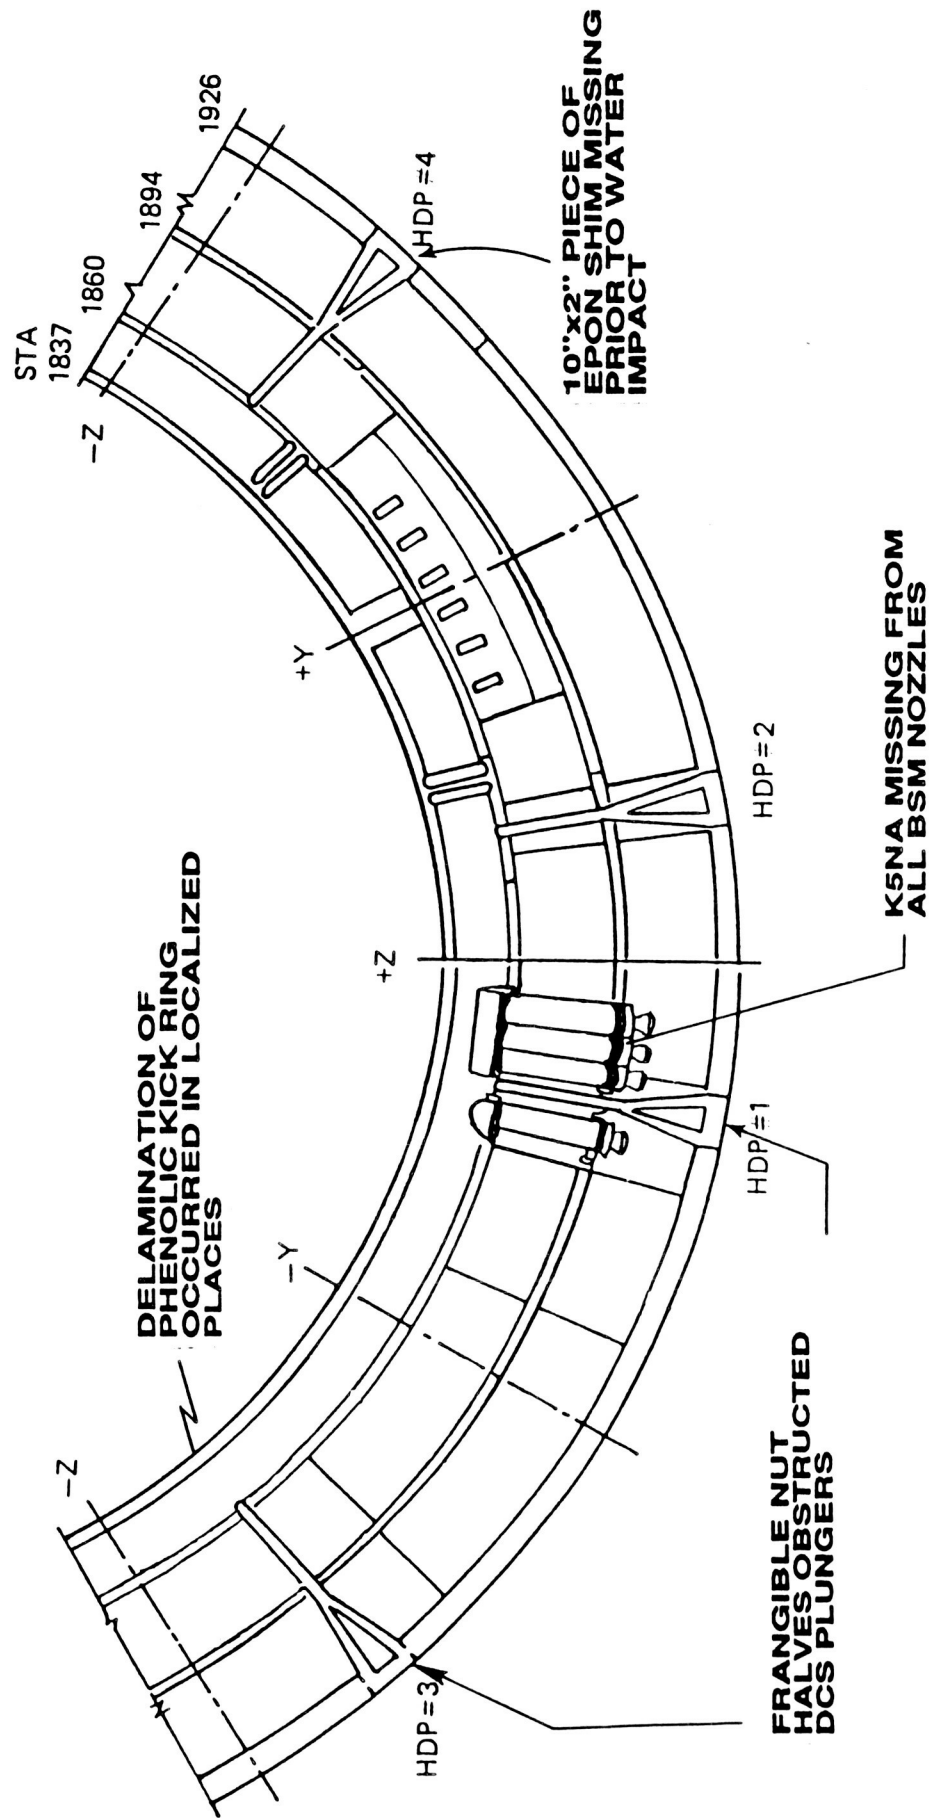
FIGURE 7. RIGHT SRB AFT SKIRT EXTERIOR TPS

The phenolic material on the kick ring delaminated in only a few locations. None of the K5NA protective domes were lost from bolt heads on the aft side of the phenolic kick ring during ascent. The aft skirt acreage TPS was in good condition. K5NA was missing from all aft BSM nozzles (Figure 7).

<u>TPS MISSING</u>	<u>DEBONDS</u>	<u>NOTES</u>
NONE	NONE	PHENOLIC PLATES ON BOTH RSS ANTENNAE WERE NOT DELAMINATED.

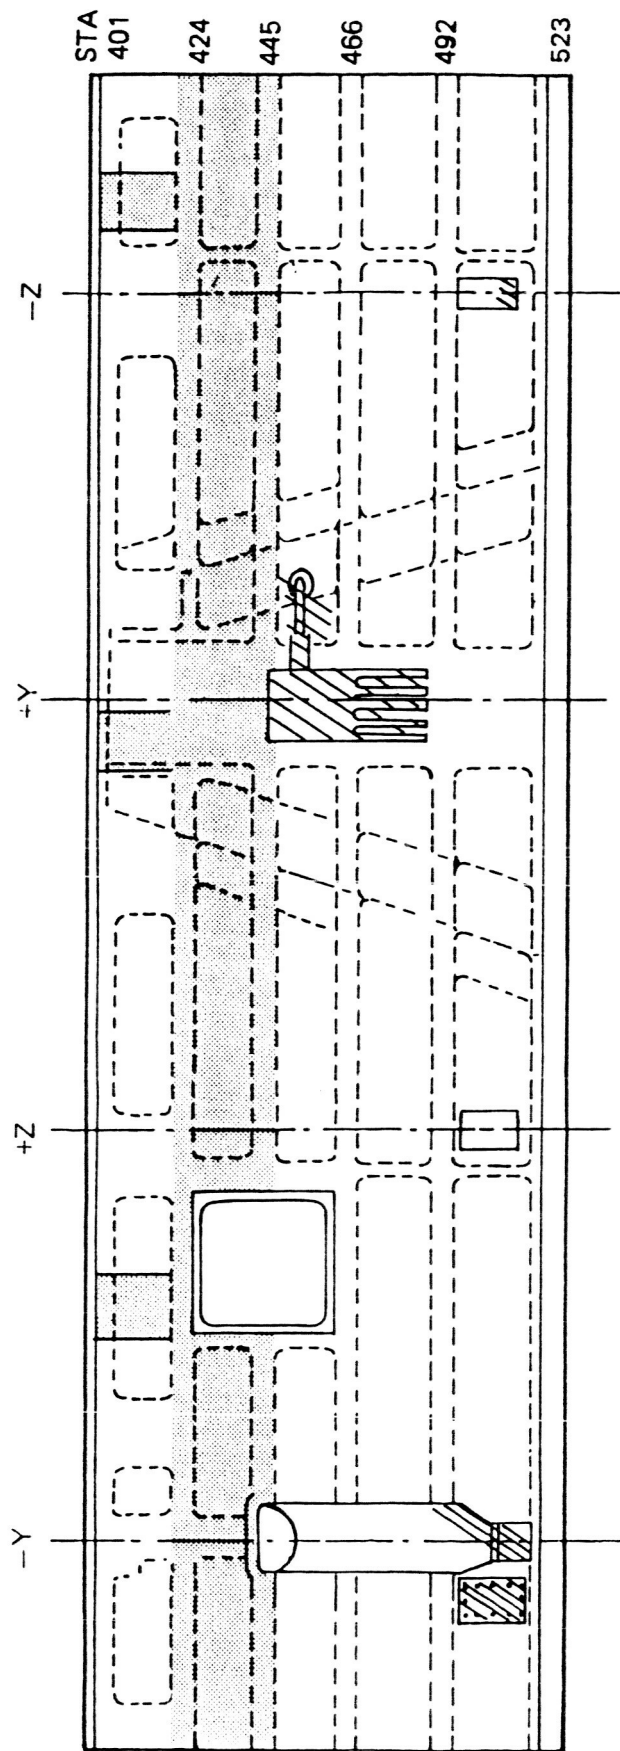
FIGURE 9. LEFT SRB FWD SKIRT

The LH forward skirt exhibited no debonds or missing TPS. The phenolic plates on both RSS antennae were not delaminated (Figure 9). The forward separation bolt and electrical cables appeared to have separated cleanly. The K5NA closeouts on the inboard corners of the RSS interface cable tray were intact. Hypalon paint had blistered on the systems tunnel cover fairing. The frustum severance ring, utilizing new pin retainer clips and lockwire, was missing no pins.

TPS MISSING	DEBONDS	NOTES
NONE	21 DEBONDS OVER FASTENERS	HYPALON PAINT BLISTERED ALONG 395 RING

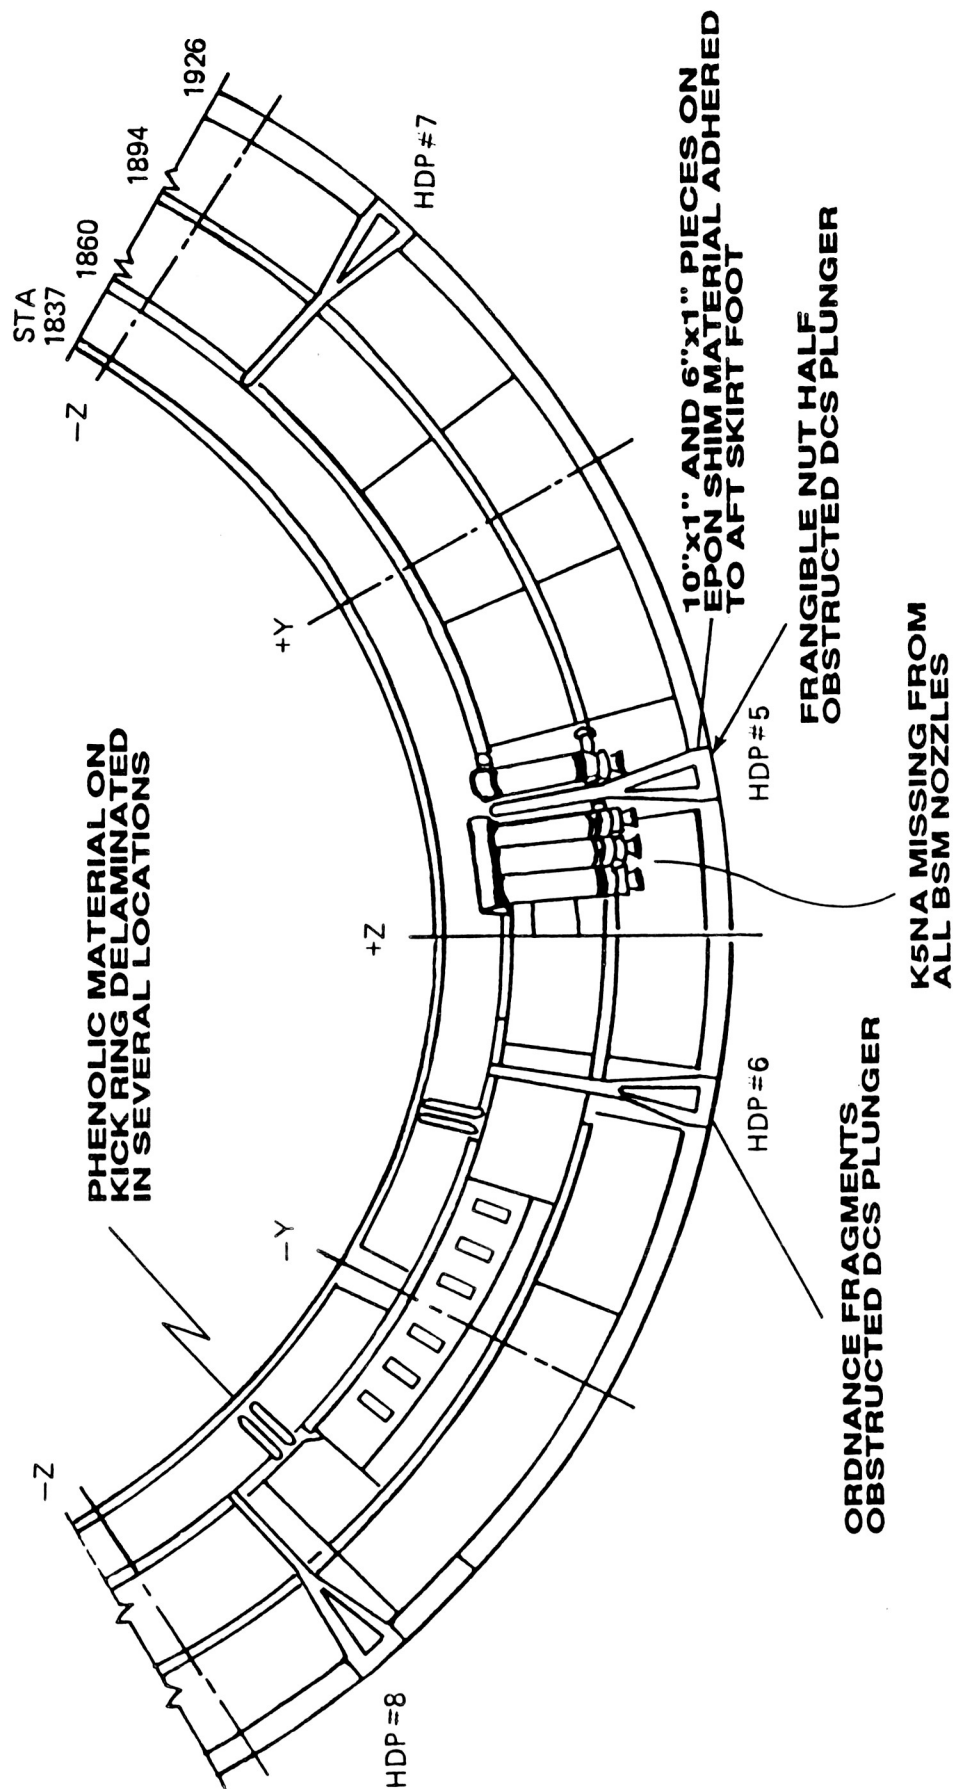
FIGURE 10. LEFT SRB AFT SKIRT EXTERIOR TPS

The phenolic material on the kick ring delaminated in several locations. None of the K5NA protective domes were lost from bolt heads on the aft side of the phenolic kick ring during ascent. The aft skirt acreage TPS was in good condition (Figure 10). K5NA was missing from all aft BSM nozzles.

////// BLISTERED HYPALON PAINT

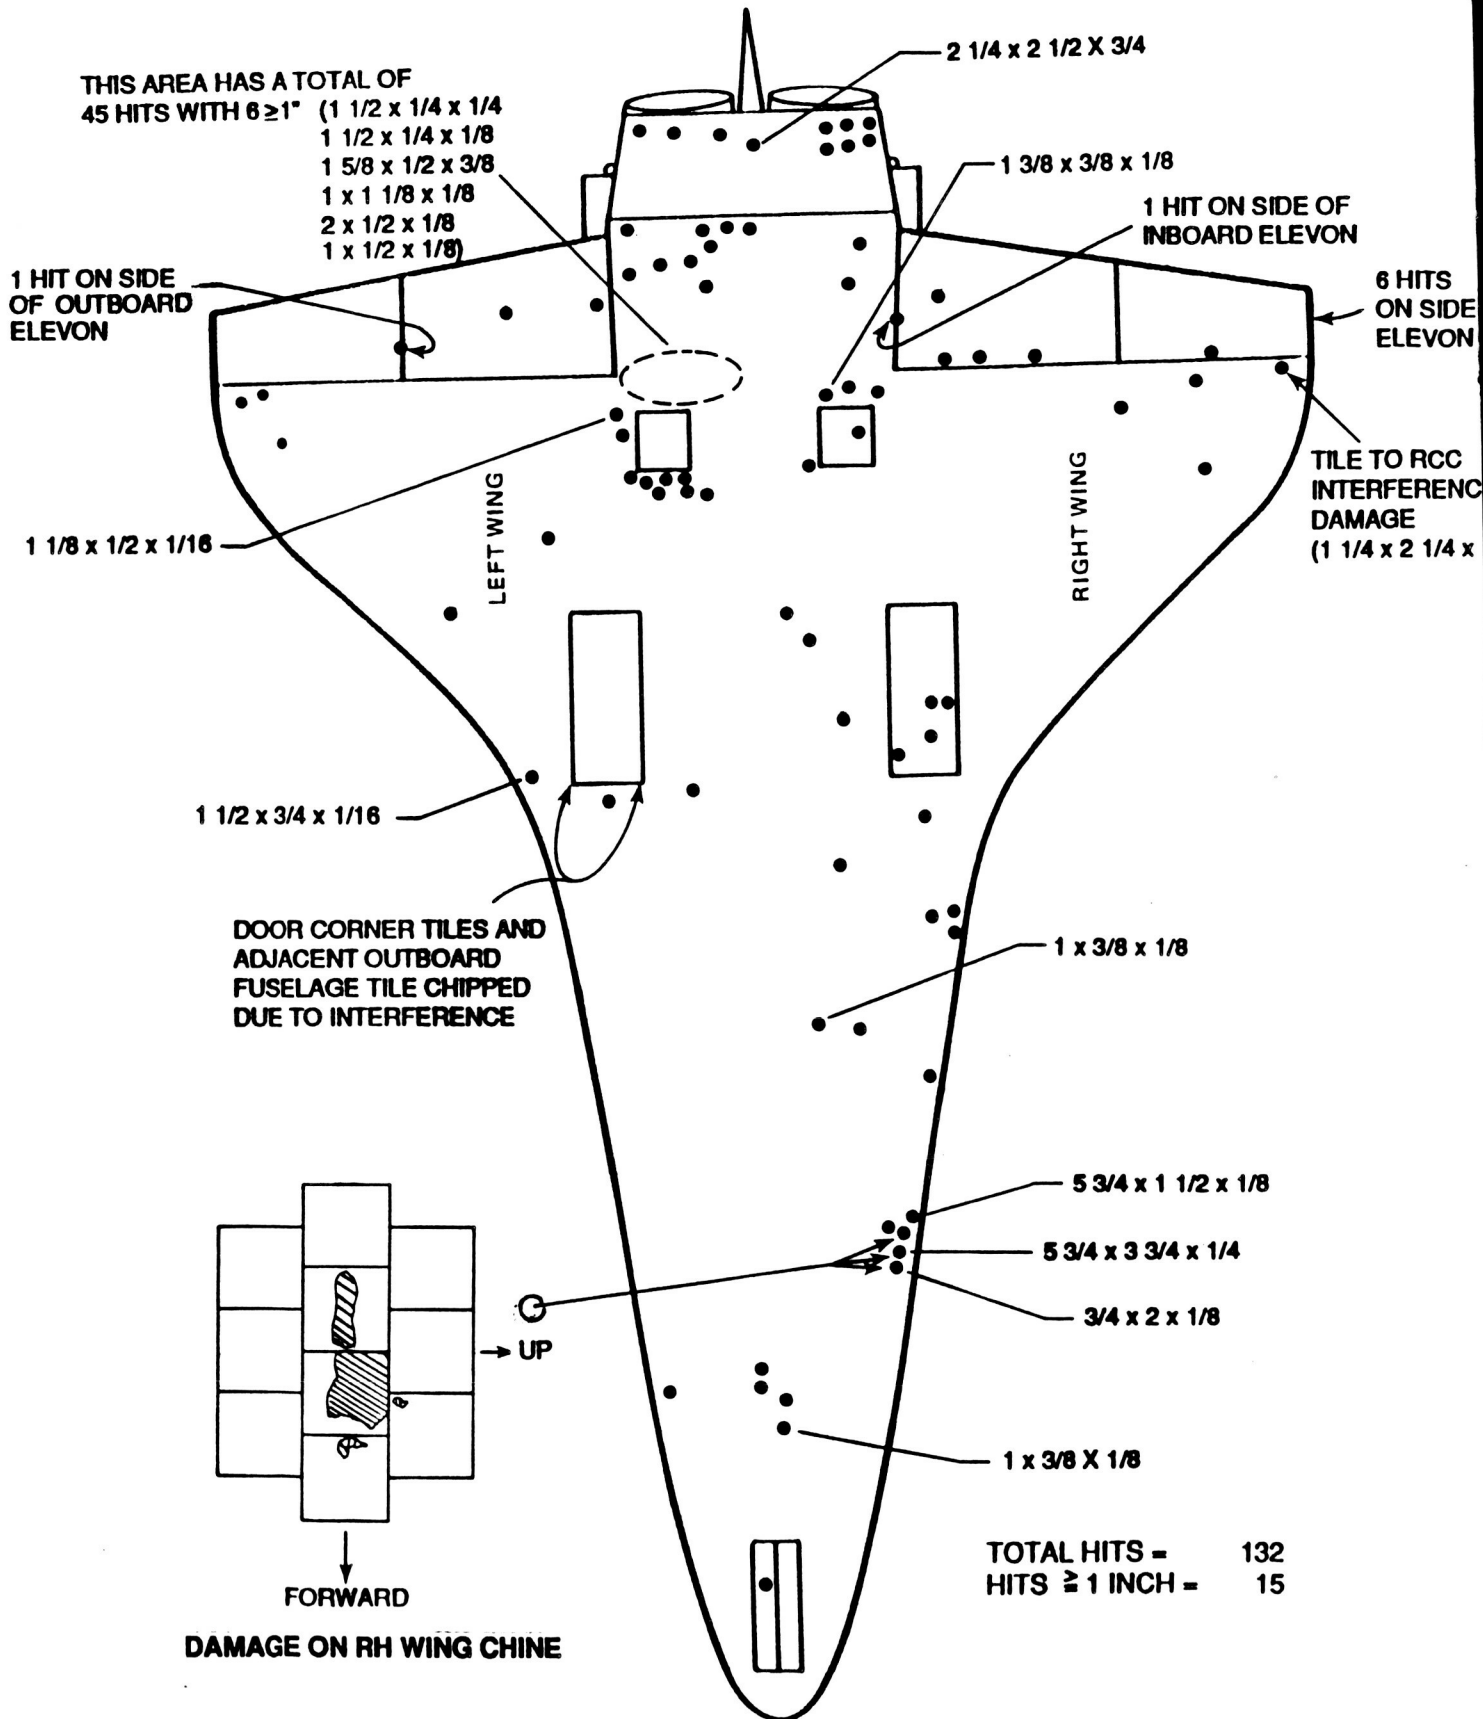
STS-35
FIGURE 11. DEBRIS DAMAGE LOCATIONS

A cluster of 45 hits, with 6 larger than one inch, occurred just aft and inboard of the LH2 ET/Orbiter umbilical opening. Similar clusters of hits have been observed in this area on previous flights and are attributed to ice/debris impacts during ET separation and/or damage from purge barrier baggie and ice during ascent. A total of 10 hits occurred on the body flap lower surface. One of these damage sites exhibited significant thermal erosion (approximately 3/4-inch in depth) and melting of the adjacent tile coating material. The largest lower surface damage site was located on the RH chine, affected four tiles, and had a maximum depth of 1/4-inch (detail of this area is included in Figure 11).

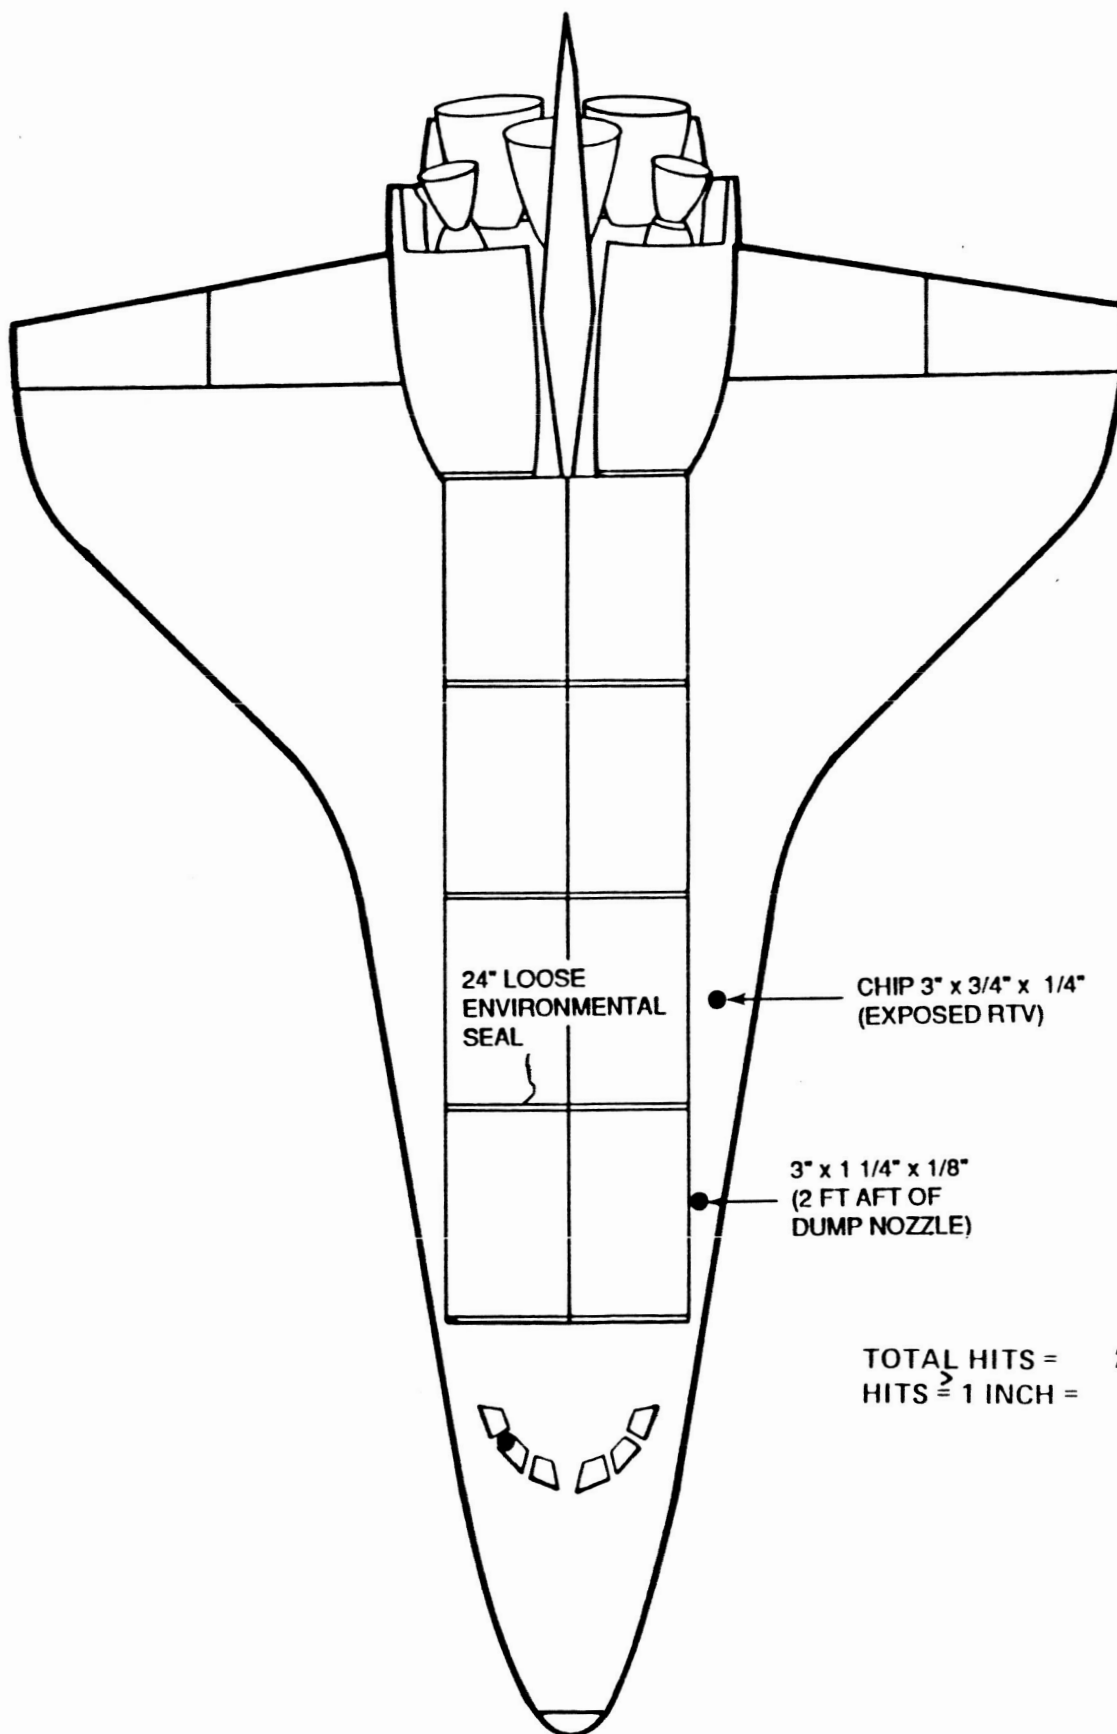
FIGURE 14. DEBRIS DAMAGE LOCATIONS

TOTAL HITS = 7
HITS \geq 1 INCH = 0

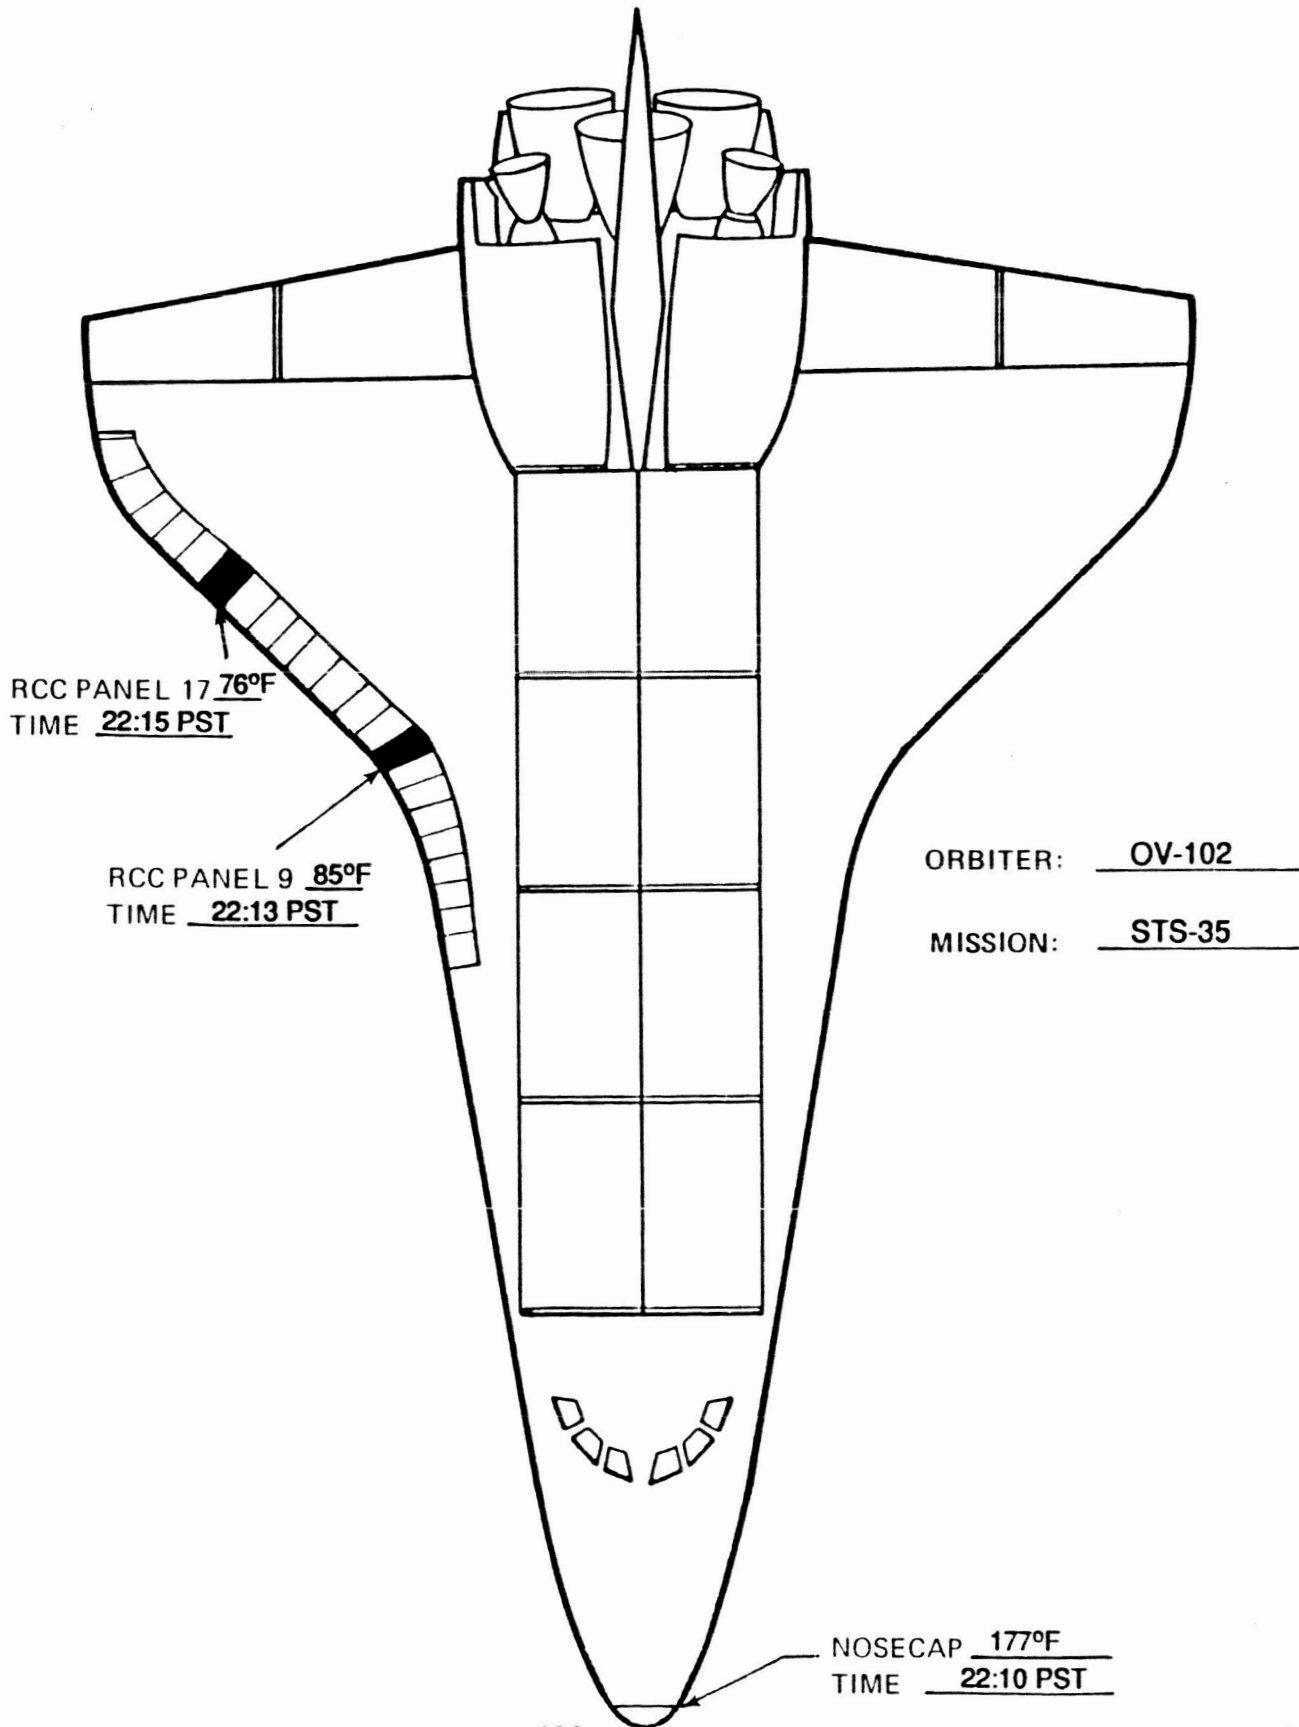
FIGURE 17. TEMPERATURE MEASUREMENTS

The KSC Shuttle Thermal Imager (STI) was used to measure the surface temperatures of several areas. Sixteen minutes after landing, the Orbiter noscap RCC was 177 degrees F, the RH wing leading edge RCC panel #9 was 85 degrees F, and the RH wing panel #17 was 76 degrees F (Figure 17).

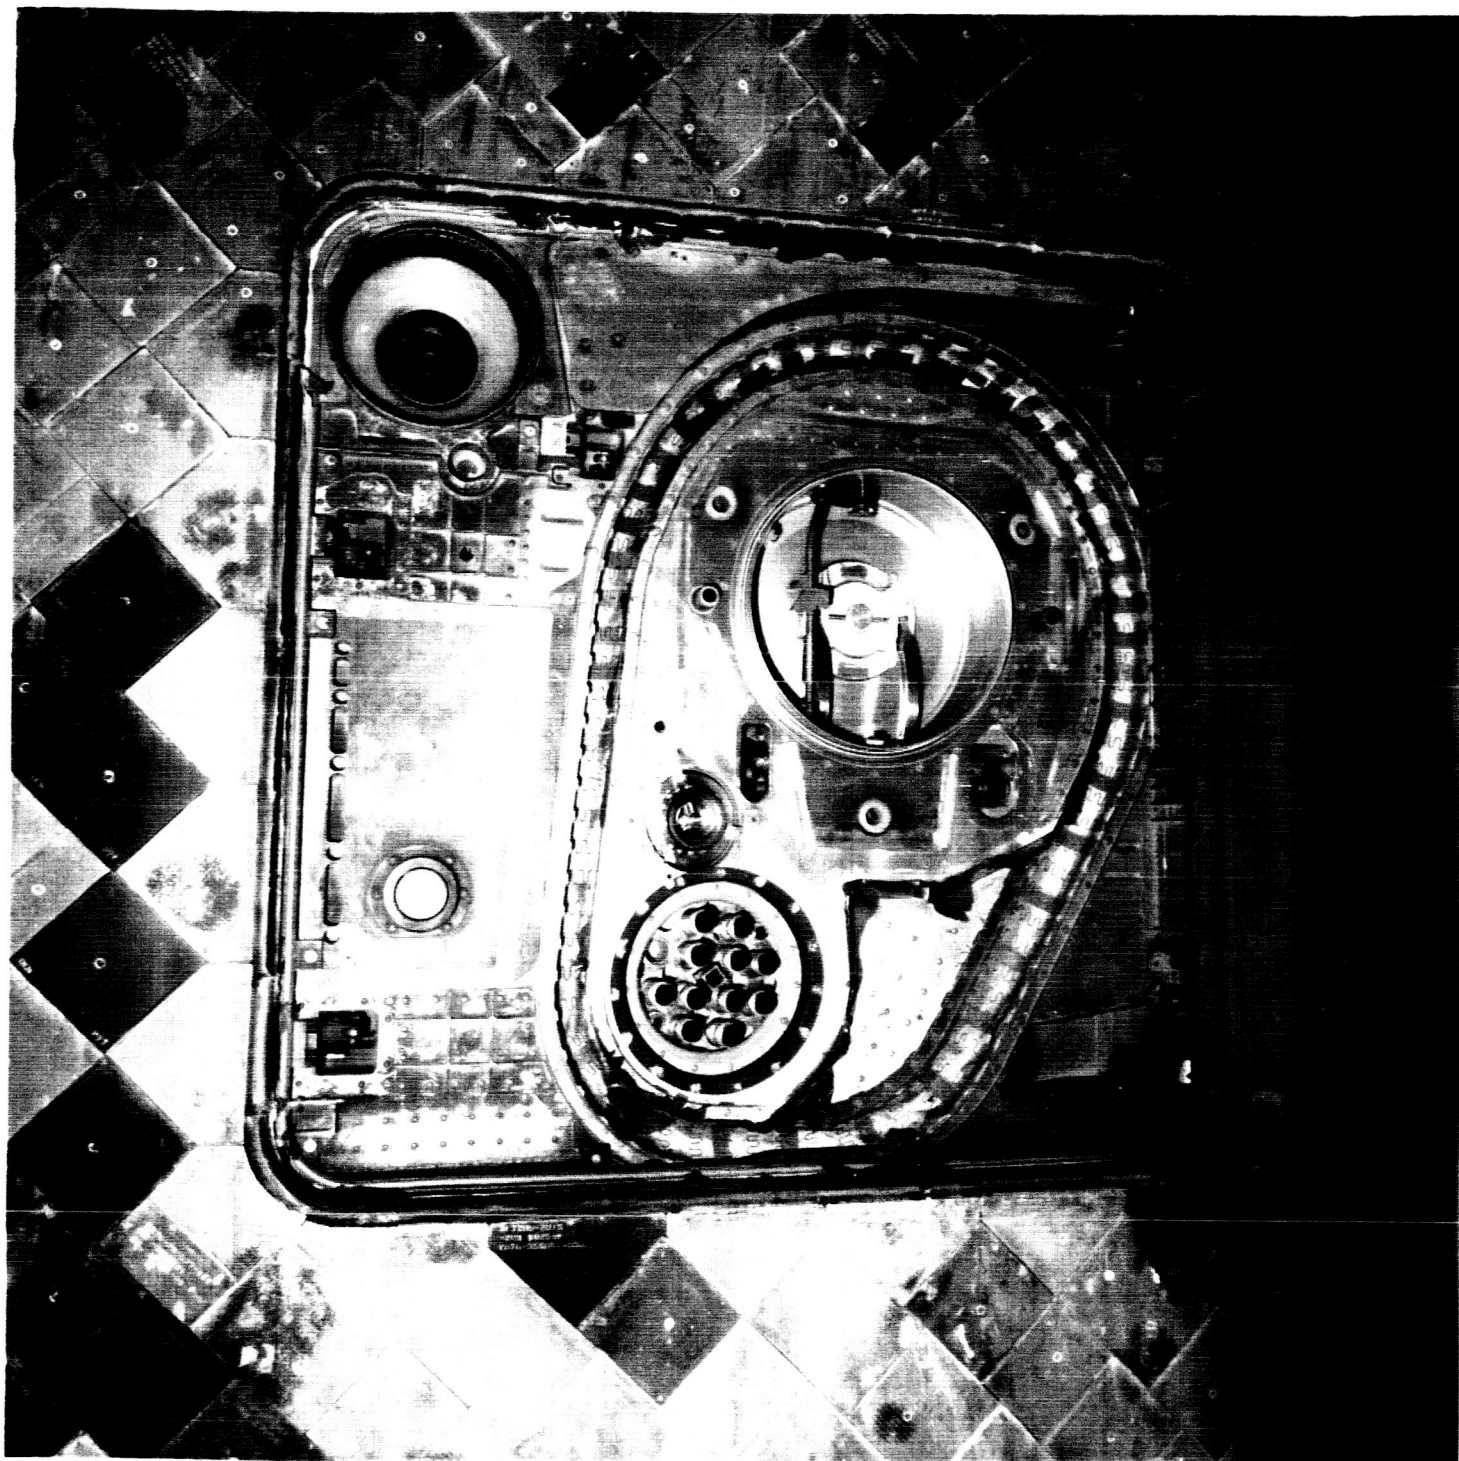
Overall view of the LO2 ET/ORB umbilical. The plunger in the EO-3 separation debris container had not seated properly.

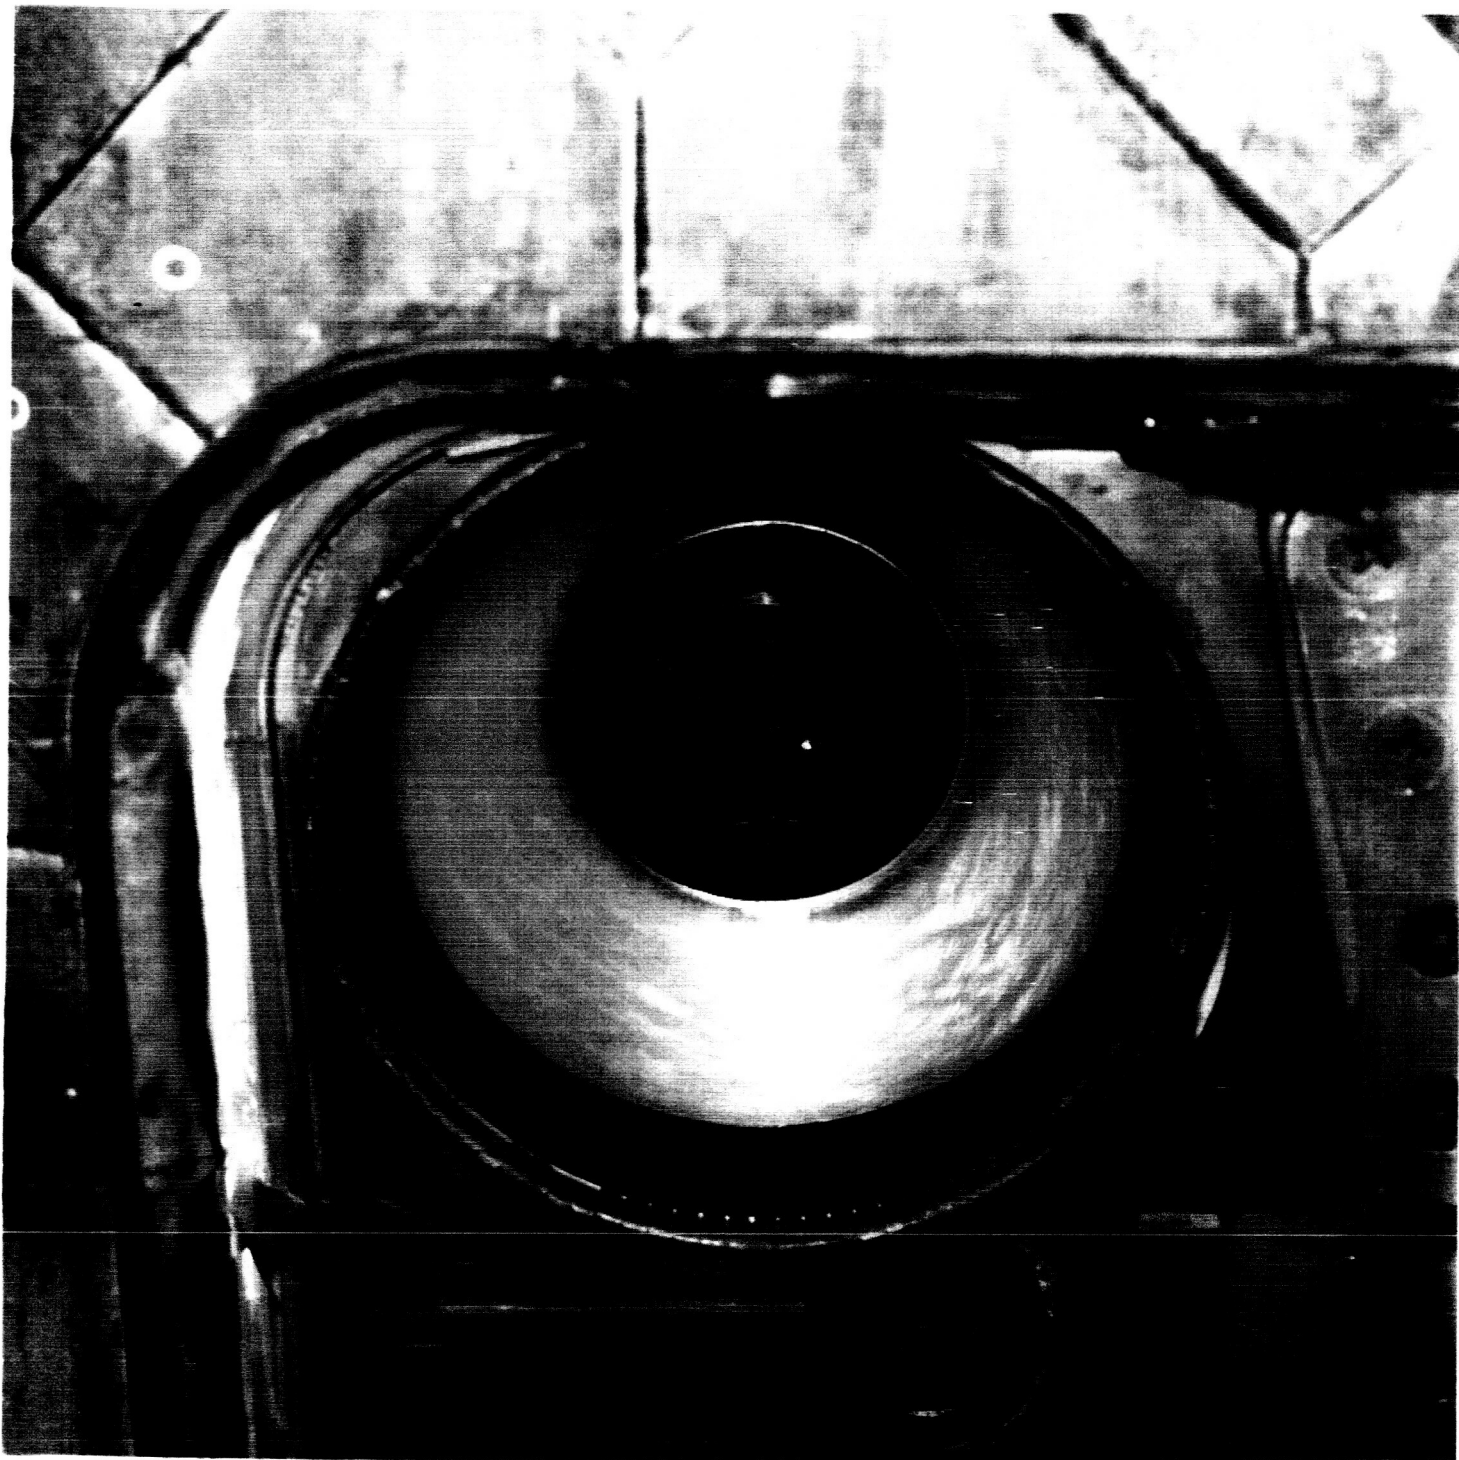
The plunger in the LO2 ET/ORB umbilical separation debris container had been obstructed by a booster cartridge

Obstruction of EO-2/3 separation ordnance debris plungers
by booster cartridges/ordnance fragments occurs frequently.

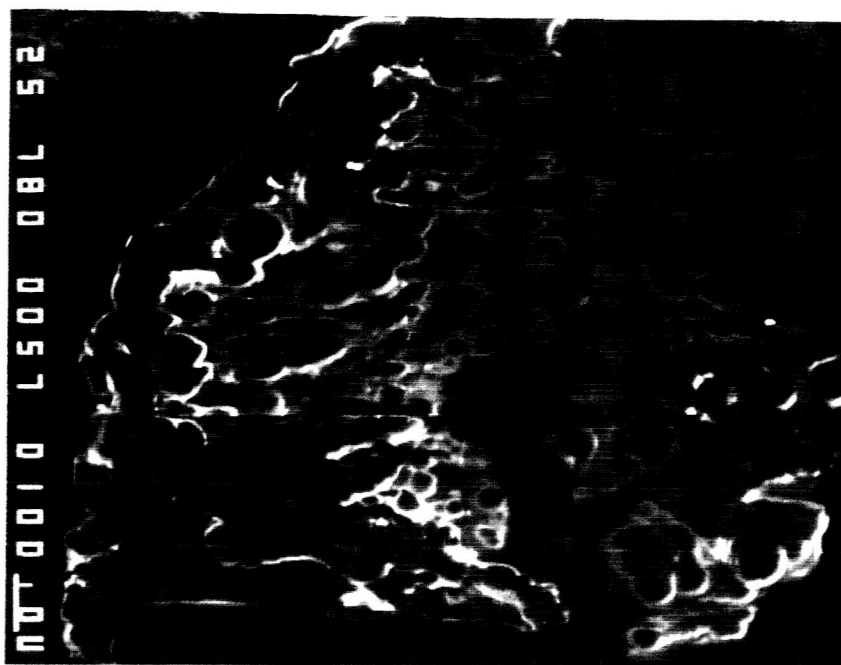
Figure 1. Low magnification SEM photomicrograph of fused or melted appearance of black tile. 78x.#9.

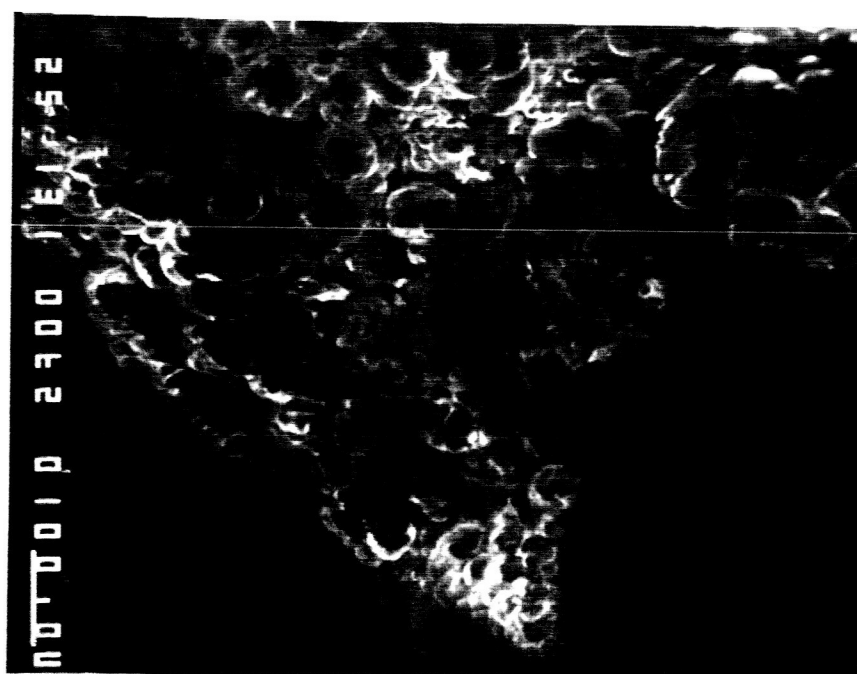
Figure 2. SEM photomicrograph of tile surface to show the spherical appearance of surface. 130x. #9. 164
